CHARACTERIZING FINAL STAGES OF CONSTRUCTION WORK

Iuri A. de Vasconcelos¹, Marcella F. Soares² and Luiz Fernando M. Heineck³

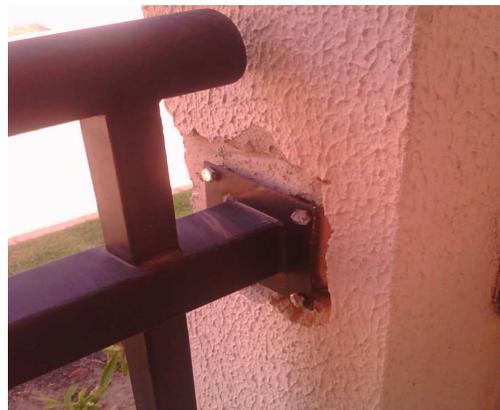
Activities related to balcony's ironmongery grids are a good example of disrupted work. Those building components were not standardized, due to the fact that every balcony has its specific dimensions and features, what gives façades an architectural uniqueness. Problems with grid's supply demanded their installation after rendering and painting as illustrated by Figura 3. This out of sequence work caused quality problems, as a simple bolt fixing was substituted for dimensionally adapting each grid to the remaining balcony width, after variable rendering and painting thickness took part of the available space for the prefabricated grids.

Figure 3: Low quality of painting

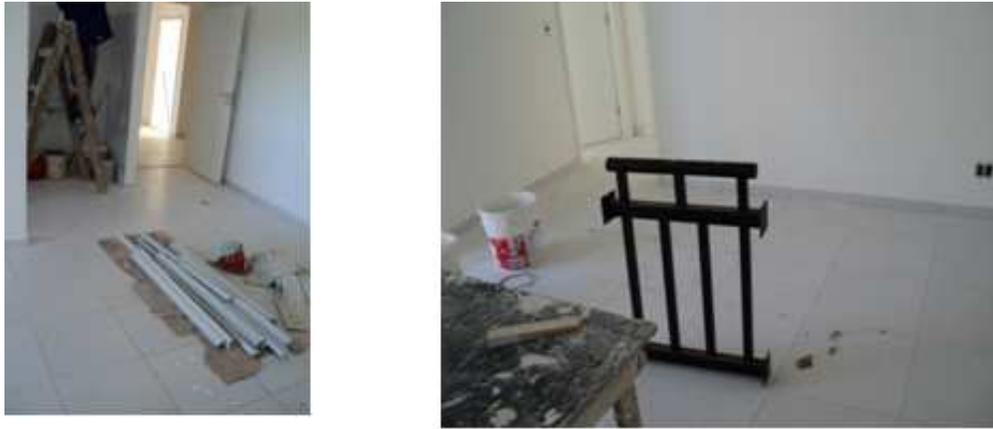
A minor problem is illustrated by Figure 4. Late delivered grids were kept in stock inside the apartment waiting for external painting conclusion. Frequently they were moved from place to place in order to allow other finishing activities to be performed inside the apartment. This ended up by causing damages to the aluminum grid.

Figure 4: Improper storage of materials

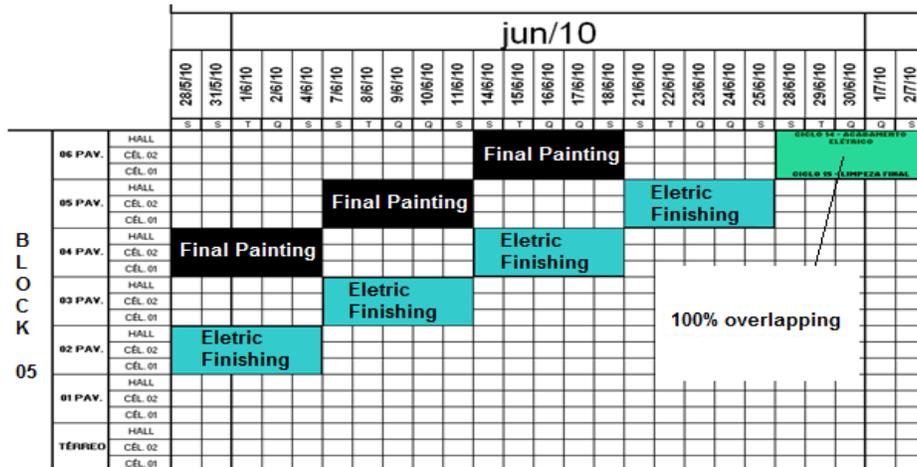
Figure 5: Planned Line of Balance

Part of the disrupted work was evident from line of balance control charts, comparing what was planned (Figure 5) with actual developments on site (Figure 6). Figure 6 shows that internal ceramic tiling being performed after internal painting while windows and doors were installed in parallel to painting. This contrary to usual technical precedence recommendations, as painting should occur after apartments are weatherproofed and all wet activities, like tiling, are finished. Performing them in opposition to common sense beliefs will end up with rework in connection to all three activities, painting, windows and doors hanging and tiling, as different trades will damage and mess each other's work.

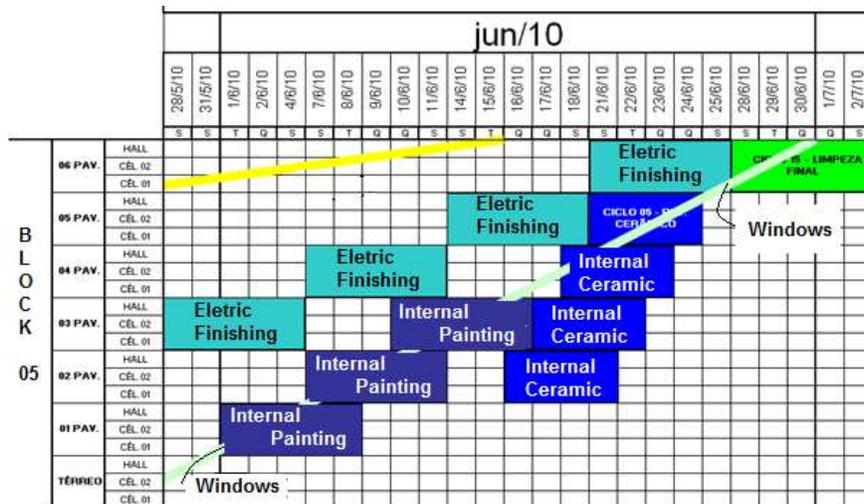
Figure 6: Actual developments on site

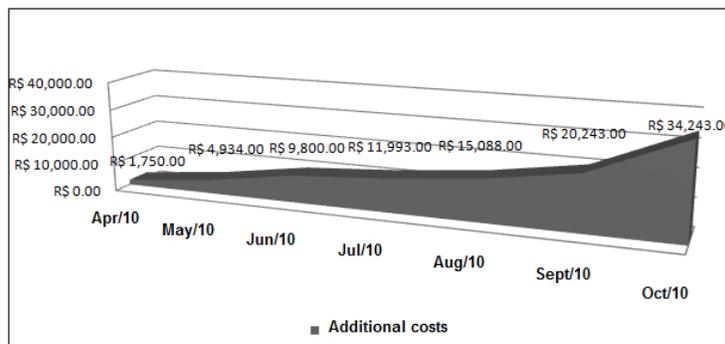
All possible disrupted work spotted in photographs or line of balance control charts were evaluated in terms of costs. Generally speaking only labor costs were taken into account as materials like extra mortar, painting, electrical wires, PVC plumbing connections, plasterboard and ceramic tiles are either relatively inexpensive or used in small quantities. Monthly costs are depicted in Figure 7 both as individual and cumulative numbers.

Figure 7: Additional costs of reworks

It is worth pointing out that 704 cases of disrupted work summed up only R\$ 34,243.00 (US\$ 20,000.00) of labor costs, compared to a R\$ 5,000,000.00 (US\$ 2,900,000.00) budget for manpower, what represents less than 0.7% of labor. Total development cost was about R\$ 15,000,000.00 and total selling price in the region of R\$ 25,000,000.00 (on average R\$ 100,000.00 – US\$ 60,000.00 - per apartment) what decreases still further the direct economical impact of disrupted work.
